Chapter 4

Preventing Ladder related Incidents in Construction Industry through Engineering Controls

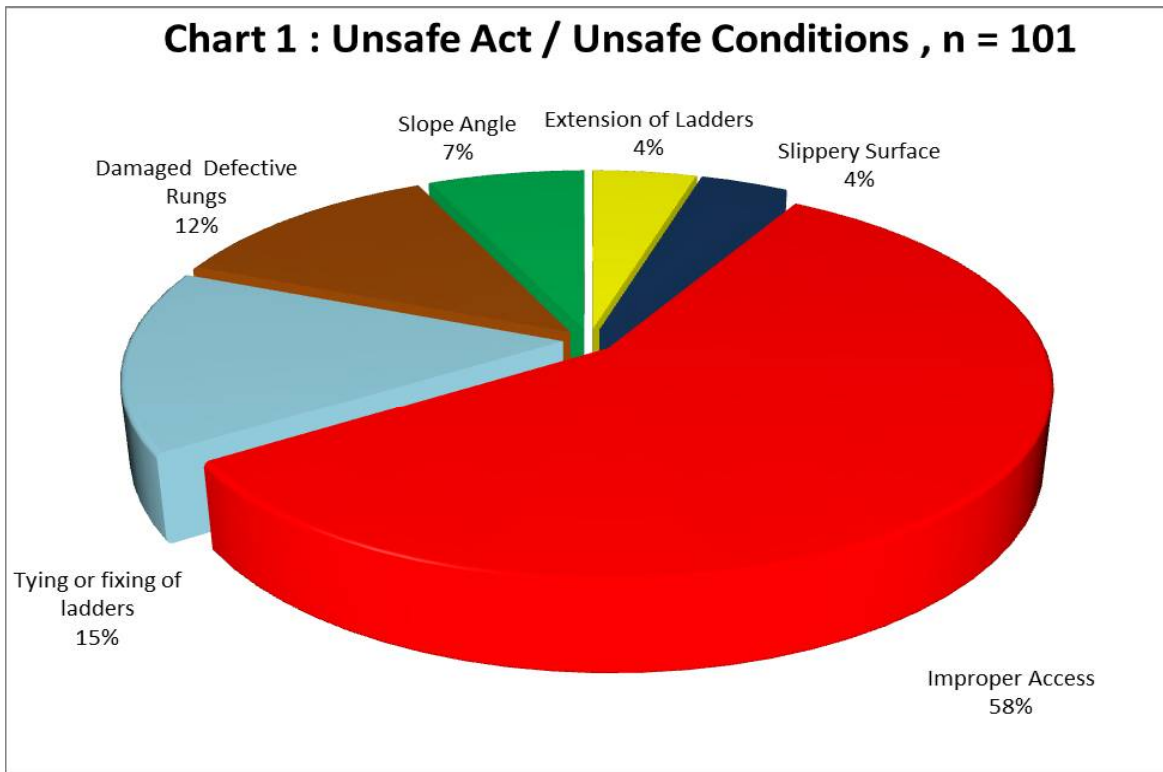
Chart showing Unsafe Acts or conditions

For each type of cases ladder related deviations were studied and their distribution for unsafe act / conditions and near miss cases are as given below

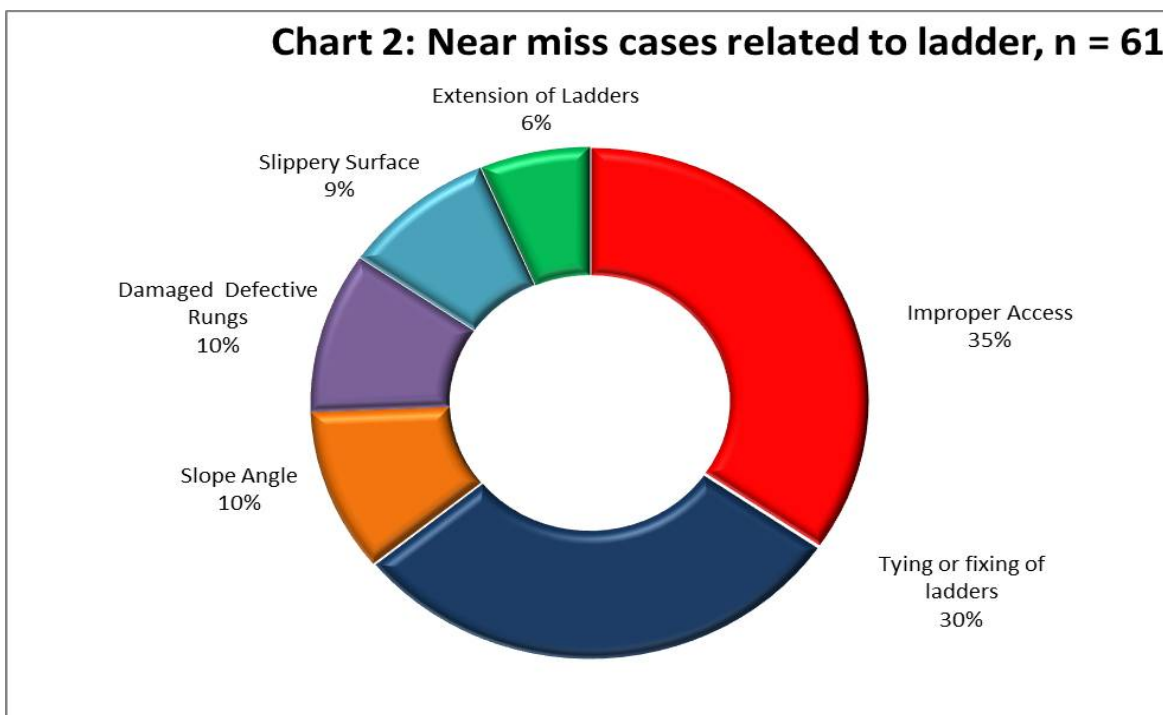
Chart showing near miss cases related to ladder

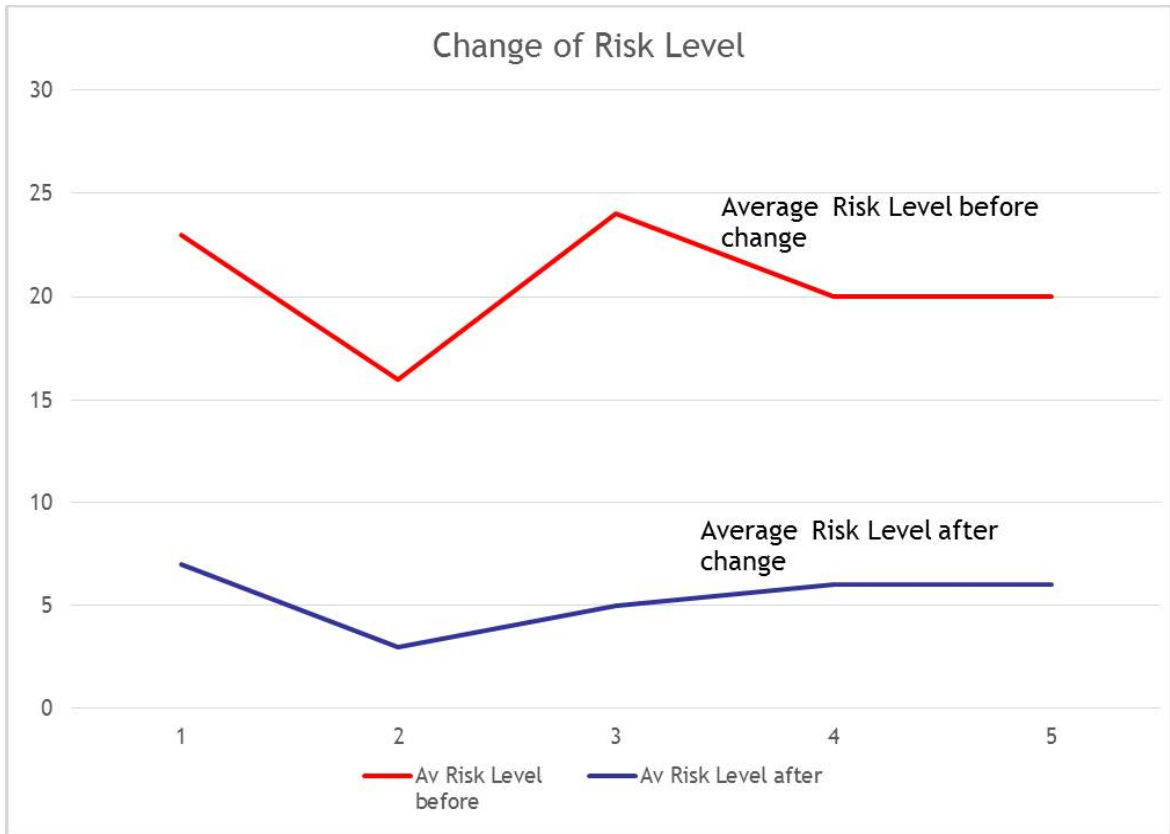
Graph showing the change of risk level

X axis: Site Location
level

Y Axis : Risk level

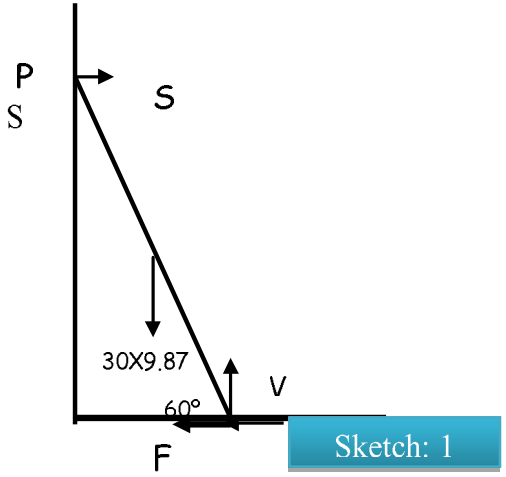
A uniform ladder of mass 30kg rests against a smooth vertical wall with its lower end on rough ground (coefficient of friction 0.25), and its top against a smooth vertical wall. The ladder rests at an angle of 60° to the horizontal. Find the magnitude of the minimum horizontal force required at the base to prevent slipping.

We need to find S, V, R and F. Let's determine first is S

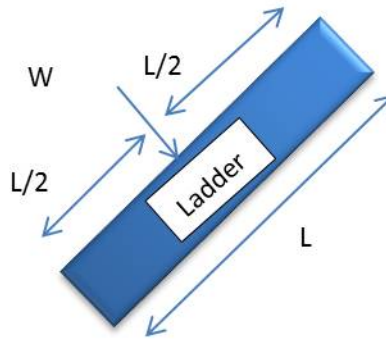
Deflection and frequency of aluminium ladder with point load at the centre

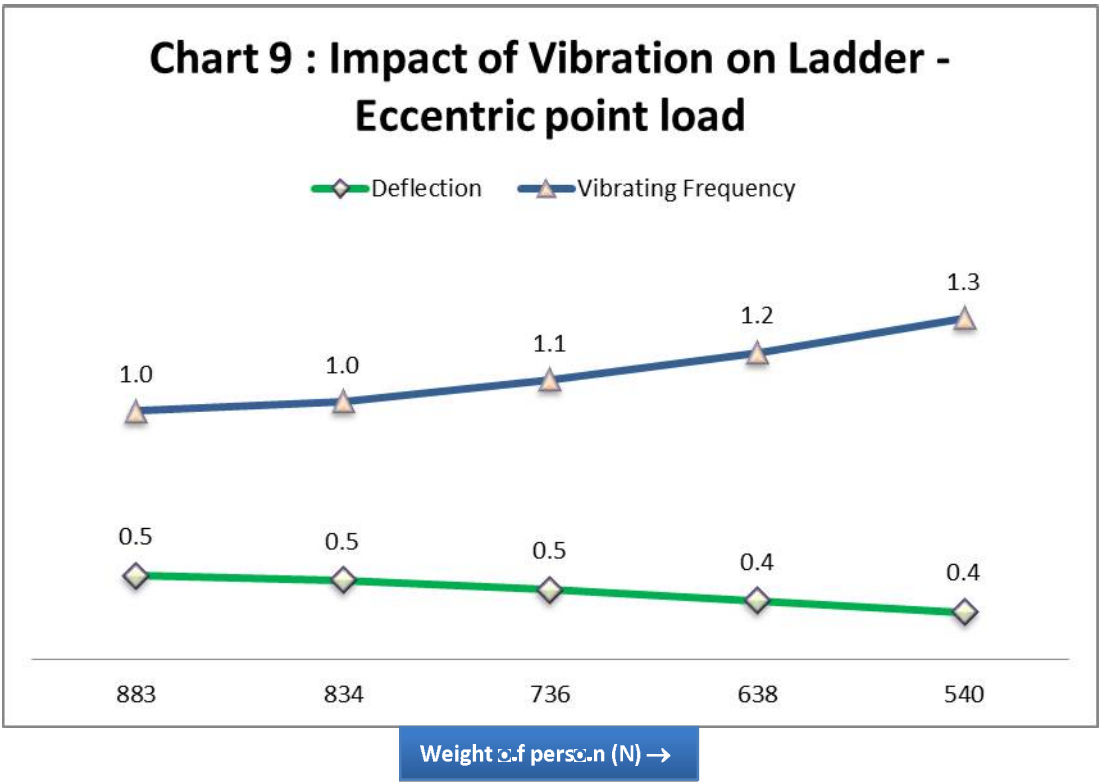
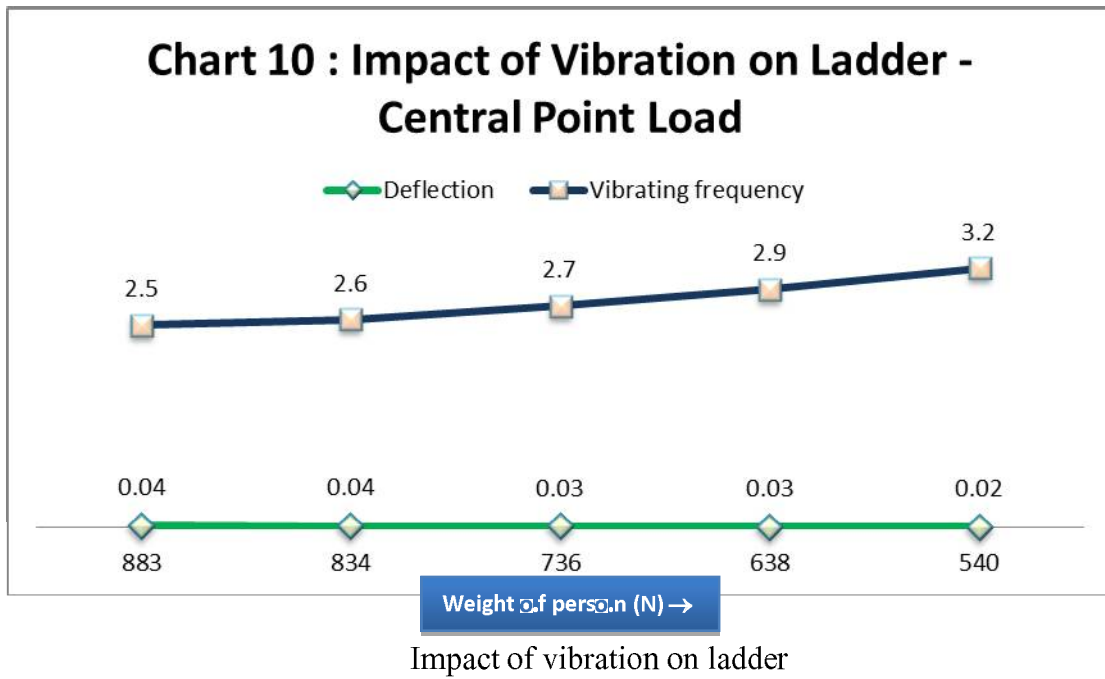
From the study we infer that the deflection of ladder is directly proportional to the increase in weight of the person for both the cases of eccentric loading as well as with point load at the centre. However, it is found that frequency of vibration of a ladder is inversely proportional to the weight of the person for both the cases, i.e., with eccentric loading as well as at the central point loading. The inverse variations of vibrational frequencies is mainly attributed to the damping factor resulted due to variation of weight of the person.

It is observed that the frequency of vibration at central point loading increases to nearly 25 times in comparison to eccentric point loading.

The details of the same are given in chart 9 and 10 as given below:

In terms of deflection and vibrational frequency, ladder was tested at point load at center as well as at eccentric point with varying body weight at a range of 55, 65, 75, 85, & 90 Kgs. In both the cases, no significant impact was observed in terms of deflection. However, there were considerable variations in vibrational frequency in comparison with eccentric as well as centric point loads. From eccentric point loading to point load at center, vibrational frequencies increased over 145%. Hence, from this research, we infer that the safe angle of ladder with respect to the horizontal is 75° and natural frequency of vibration tends to be higher when any person moves past the center portion of the ladder.

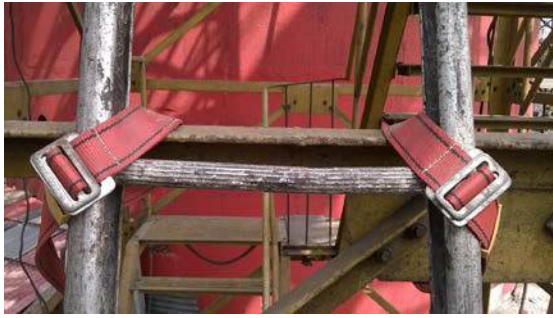
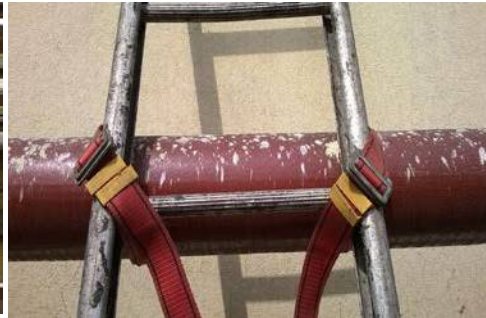
Sketch of latched ladder
